## Influence of Track Ten on Flood Levels at Loch Sport

**FINAL 2**

April 2026

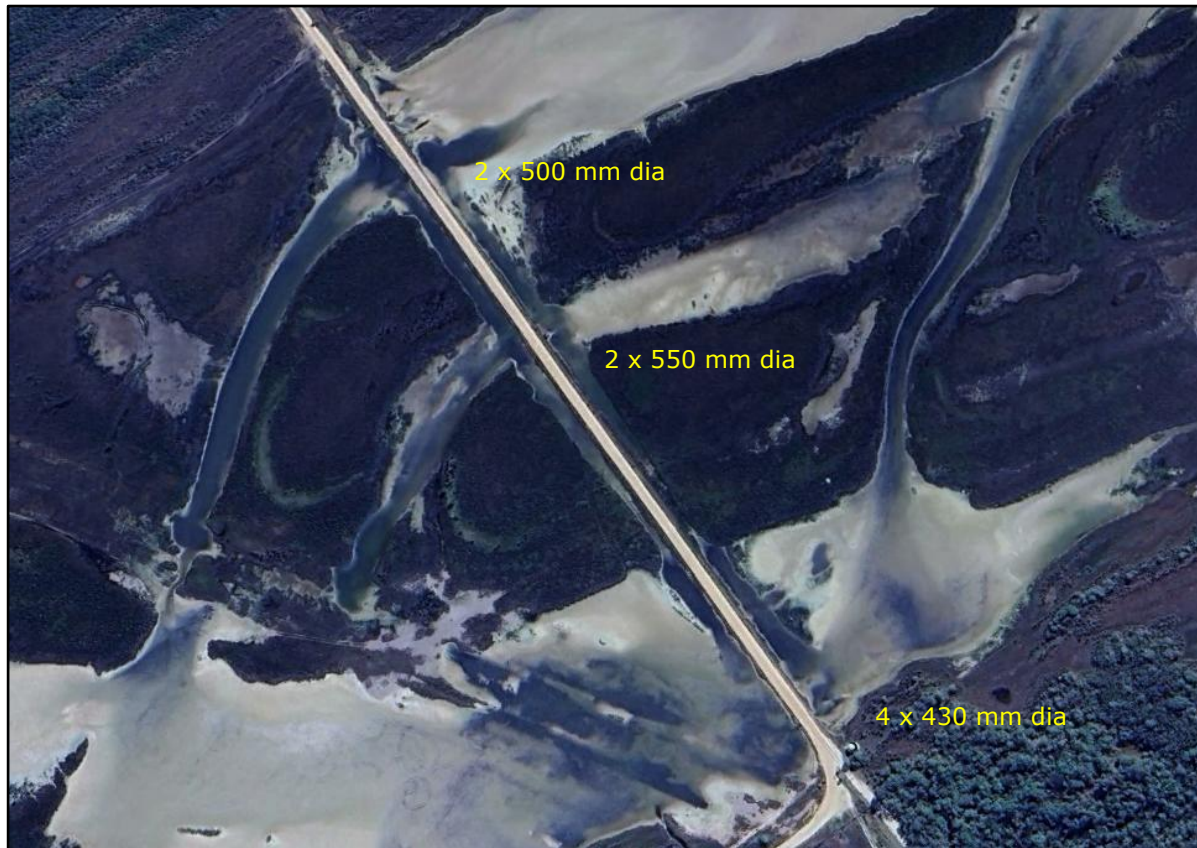
**Figure 3: Location of Track Ten culverts**

There is a total of eight culverts under Track Ten, in three banks (Figure 3) (Appendix C). All culverts are relatively low capacity (Figure 4) but are adequate to allow passage of tidal flows, wind driven flows and local runoff under normal (non-flood) conditions.

The first bank consists of two 500 mm diameter culverts at the northwest end of Track Ten causeway. The next bank is 132 m further southeast (two 550 mm diameter culverts). Approximately 270 m further southeast, are four smaller culverts, 430 mm diameter each. There are two upper culverts and two lower culverts.

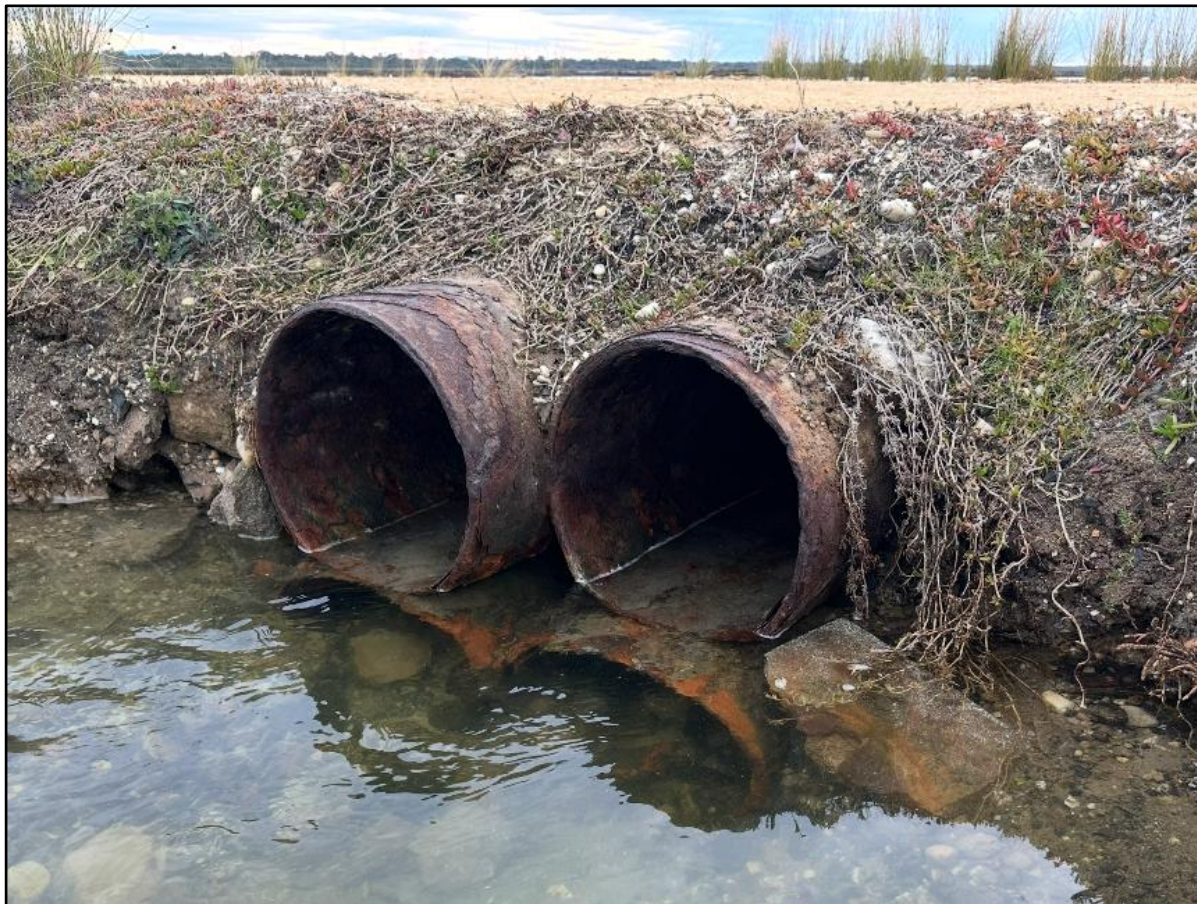
**Figure 4: Culverts at the southeastern end of the Track Ten causeway. This is a bank of 4 culverts, 2 upper and 2 lower. Culvert diameter is 430 mm.**

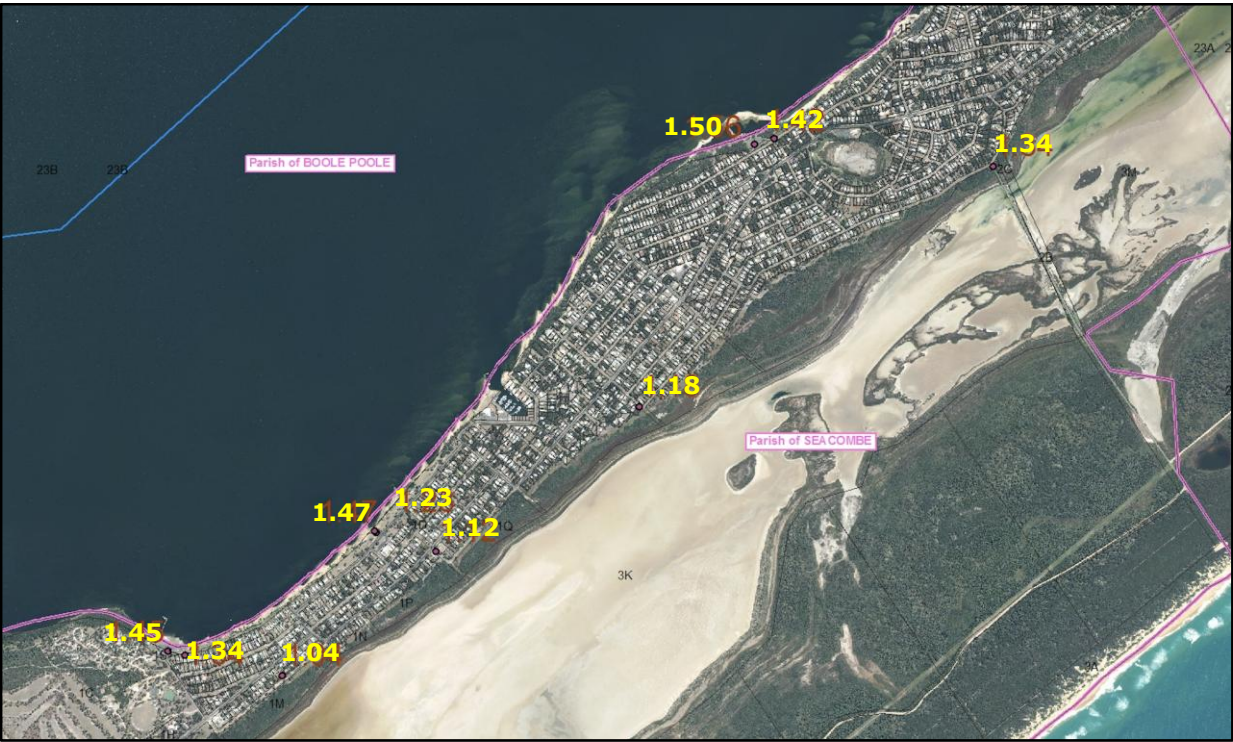
**Figure 6: Recorded peak flood levels at Loch Sport, July 2007 flood**

There are also observed peak water levels at Loch Sport adjacent to Lake Victoria and Lake Reeve. These were compiled by the East and West Gippsland CMAs (Table 1; Figure 6).

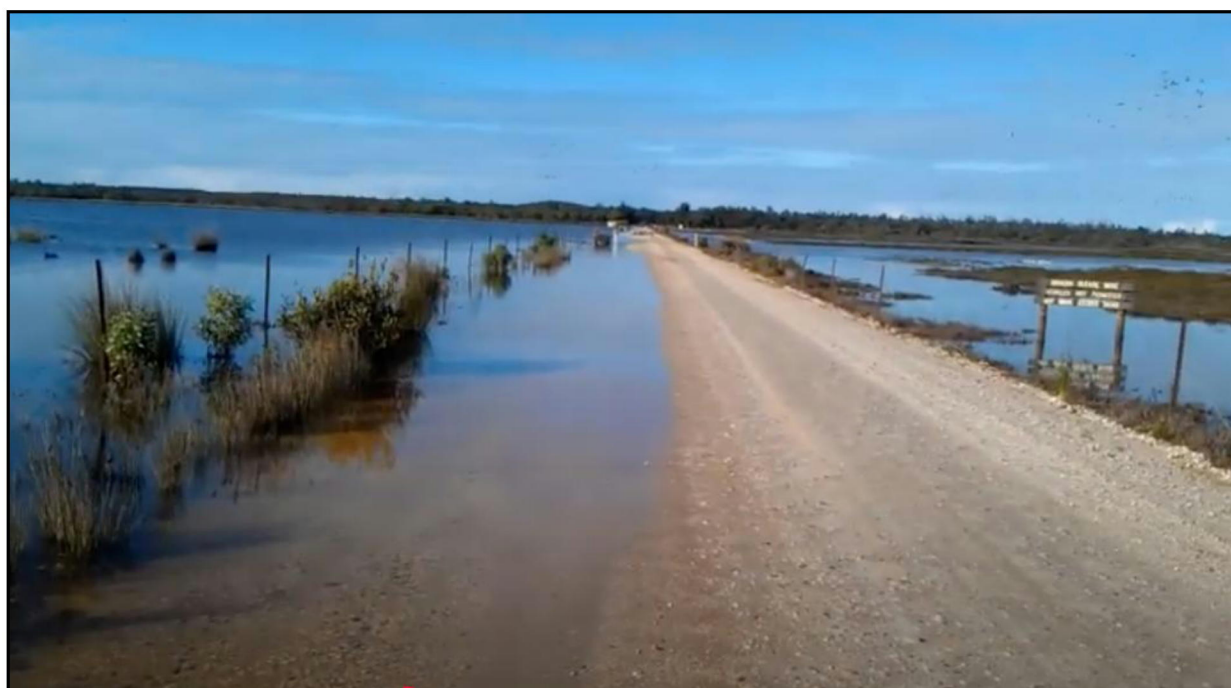
**Figure 7: Track Ten causeway during the 25 June 2007 flood<sup>9</sup>**

Track Ten would have contributed to higher water levels at this time but the effect at Loch Sport would be limited and below the peak flood levels recorded in Table 1. Based on Figure 7, the water level appears to be approximately 0.6 to 0.7 m (based on a causeway height of about 0.8 m).

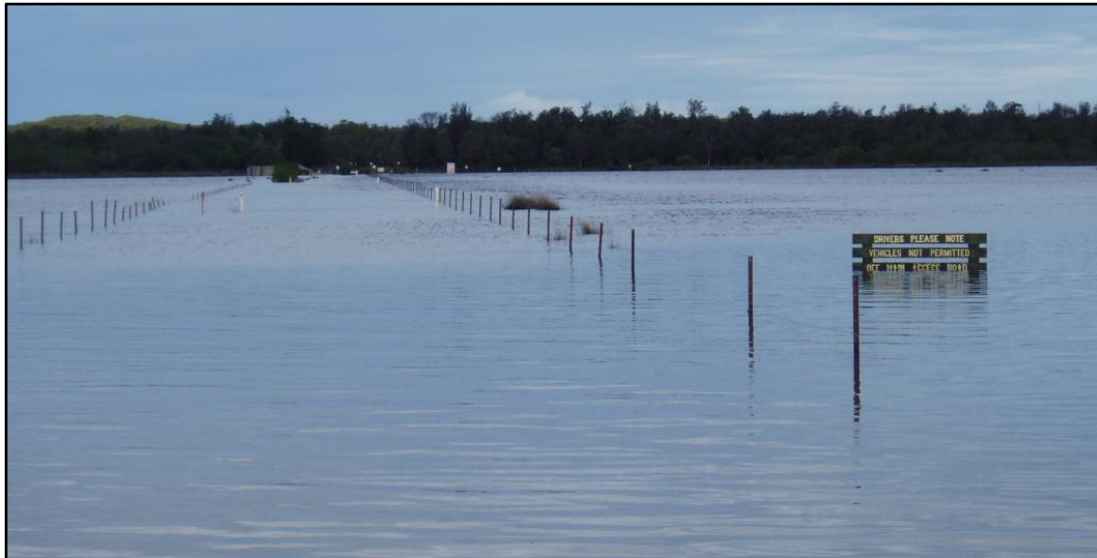
**Figure 8: Track Ten causeway 1 July 2007<sup>10</sup>. Water depth is approximately 200 mm deep at the white posts**

As the Gippsland Lakes flood progressed, the water level at Track Ten increased to above 0.8 m and the track was overtopped. Figure 8 shows the track completely inundated, water levels are the same on either side of Track Ten which means the track was not affecting the water level at Loch Sport.

There were no recorded levels at Track Ten during the 2007 flood, but I estimate that the water depth over the road, when the photo, Figure 8, was taken, was about 200 mm. This implies the water level at the Track Ten Causeway was approximately 1 m (based on a causeway height of 0.8 m).

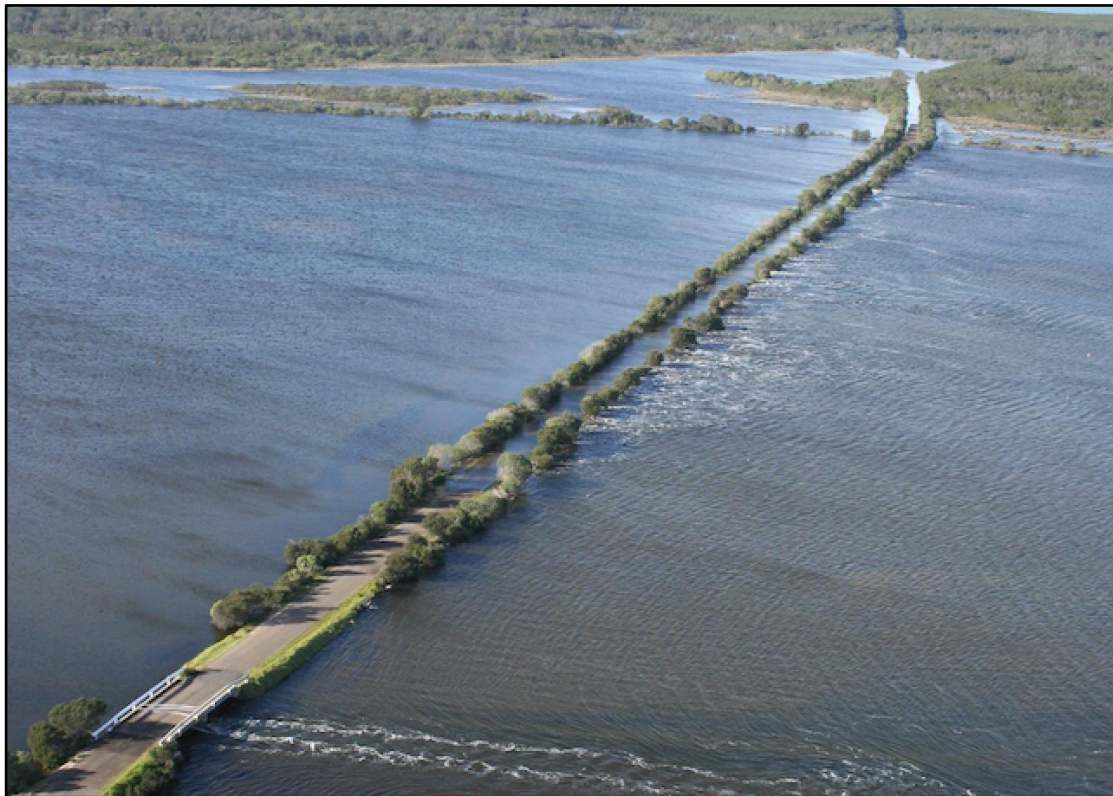
**Figure 9: Overtopping of Stockyard Hill causeway<sup>11</sup>**

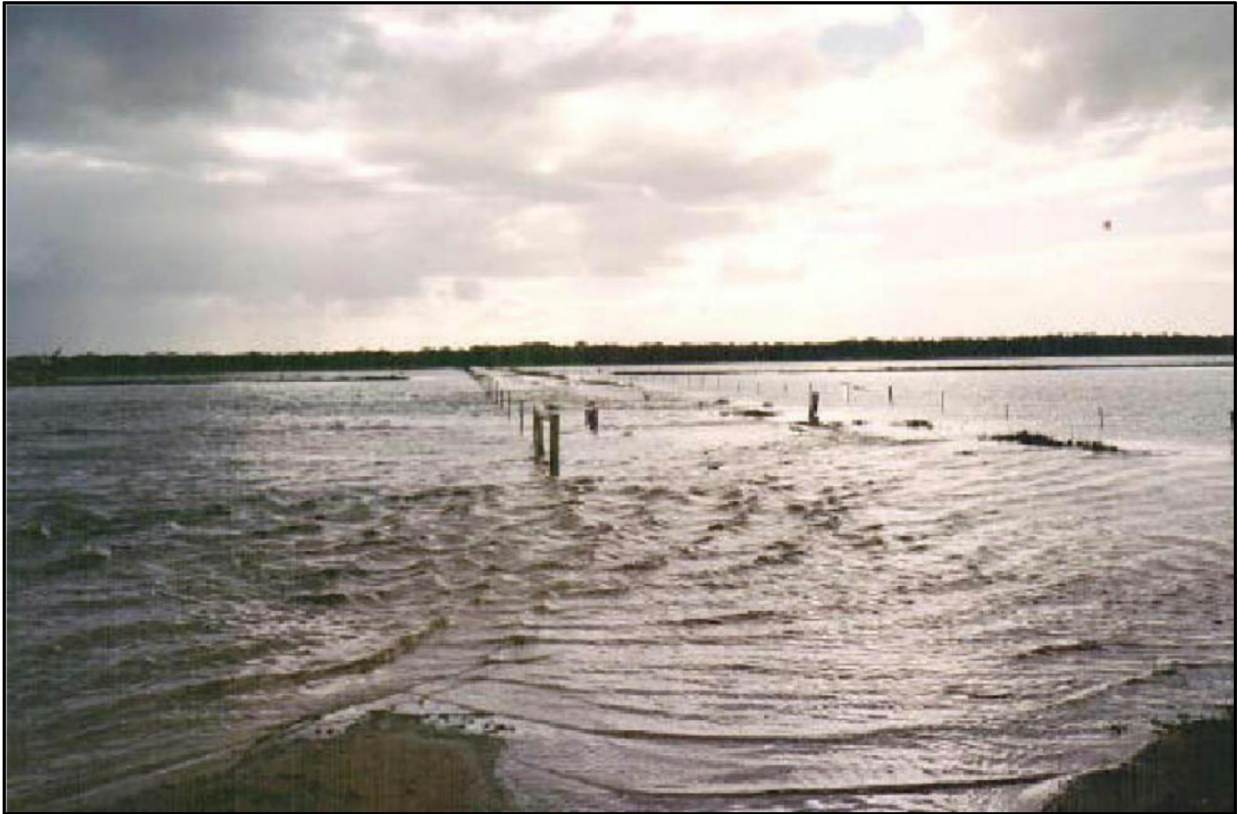
**Figure 12: Inundation of Track Ten during the November 1995 flood<sup>18</sup>**

The 2007 flood was larger than the floods in 1993 and 1995. Photographs show that Track Ten was overtopped in both these floods (Figures 12 and 13). These photos appear to show similar flood conditions, but it is not known if they were taken at the peak.

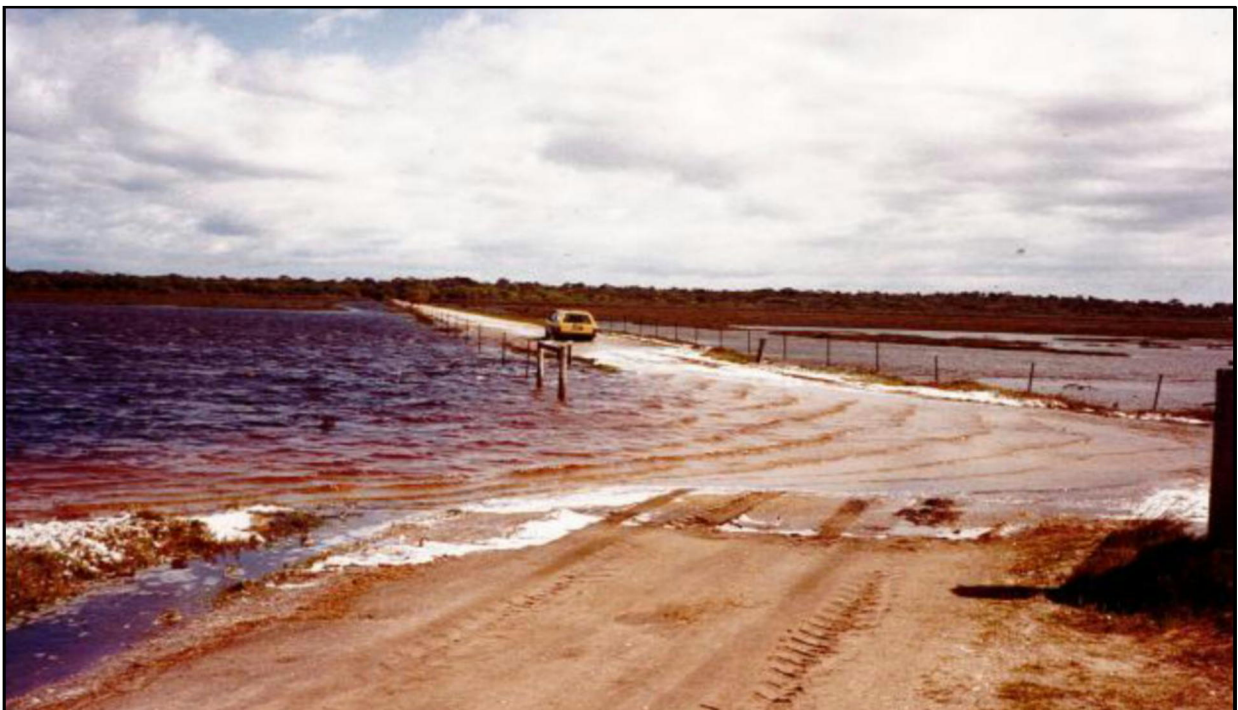
**Figure 13: High water level at Track Ten during the September 1993 flood<sup>19</sup>**
